FIELD EVALUATION UPDATE ON THE VIPR™ SYSTEM – 2020

Ross D. Rutherford
David L. Arthur
Lummus Ag Technology
Lubbock, TX
Gabe J. Sweers
Bratney Companies
Des Moines, IA
Mark D. Cory
Lummus Ag Technology
Savannah, GA

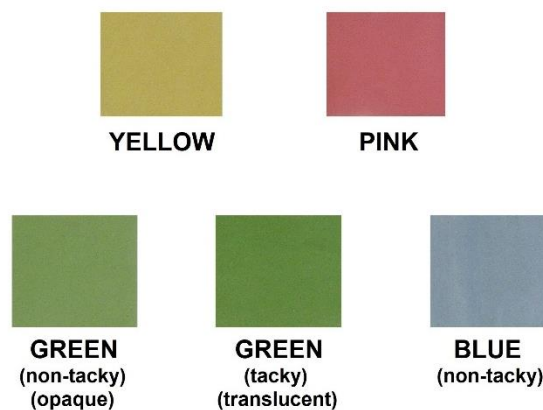
Figure 3. Module wrap colors evaluated in the 2020 VIPR™ Testing.

TAMA, the manufacturer of round module wrap, provided sheets of five (5) colors of module feeder plastic wraps for use in the 2020 testing. The sample colors were conventional yellow and pink, along with two types of green (non-tacky/opaque and tacky/translucent) and blue (non-tacky). Figure 3 shows the colors used in the study.

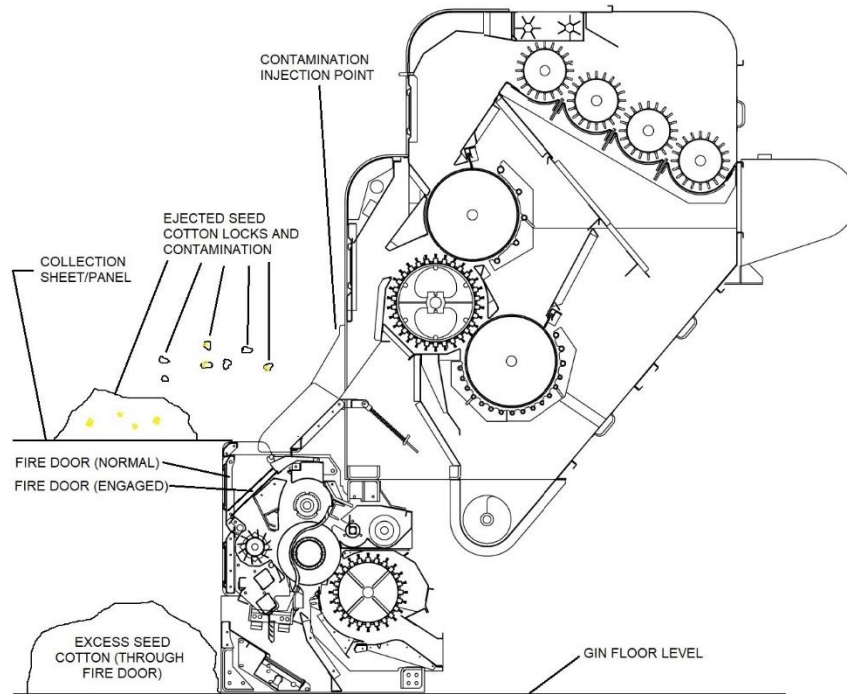
Figure 4. Testing Set-up for VIPR™ Evaluation – 2020.

The 2020 evaluation protocol for both sites was as follows. All module wrap color samples were cut into 2" x 2" squares, three (3) replication per wrap color were performed with eight (8) wrap injections per replication across the Feeder. The test set-up configuration for the machinery at Southeastern Gin and Spade Co-op is shown in Figure 4.

Each of the lines being tested was isolated, so that the rest of the gin plant could continue commercial operation on the balance of the machinery. On the test line, the fire door on the gin front was engaged, so that the seed cotton and any undetected contamination pieces would fall to the floor, allowing for collection and accounting of the undetected pieces at the end of the replication. A photo of a typical ejection during the testing is shown in Figure 5.

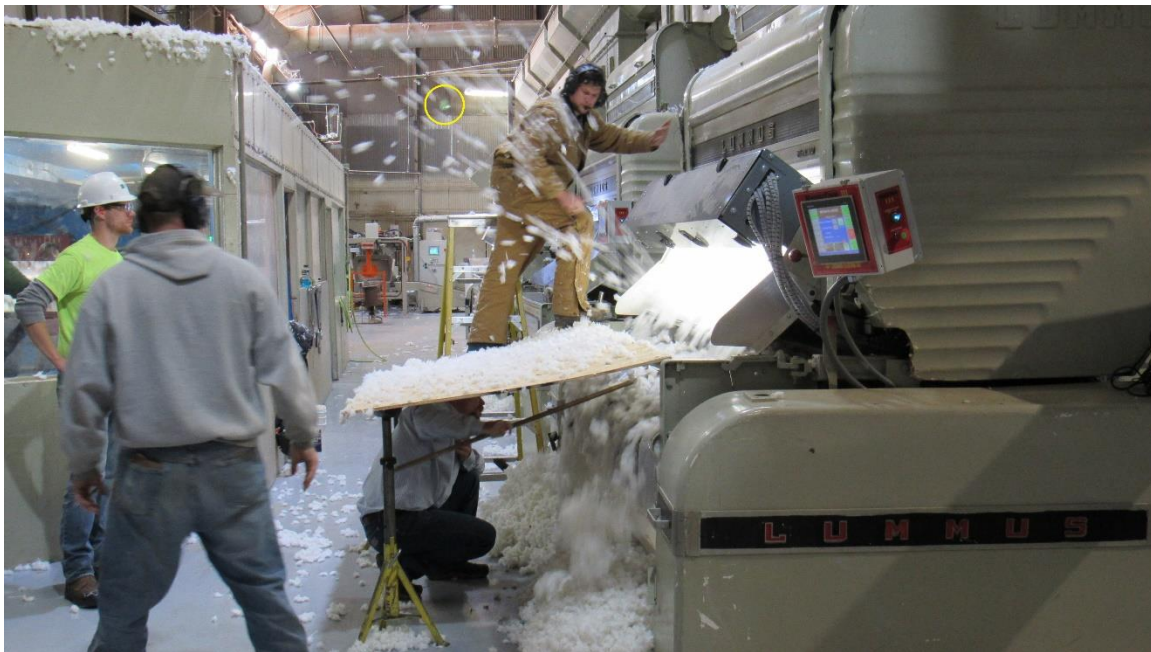
Figure 5. Contamination ejection (circled in yellow) at Spade Co-op Gin.

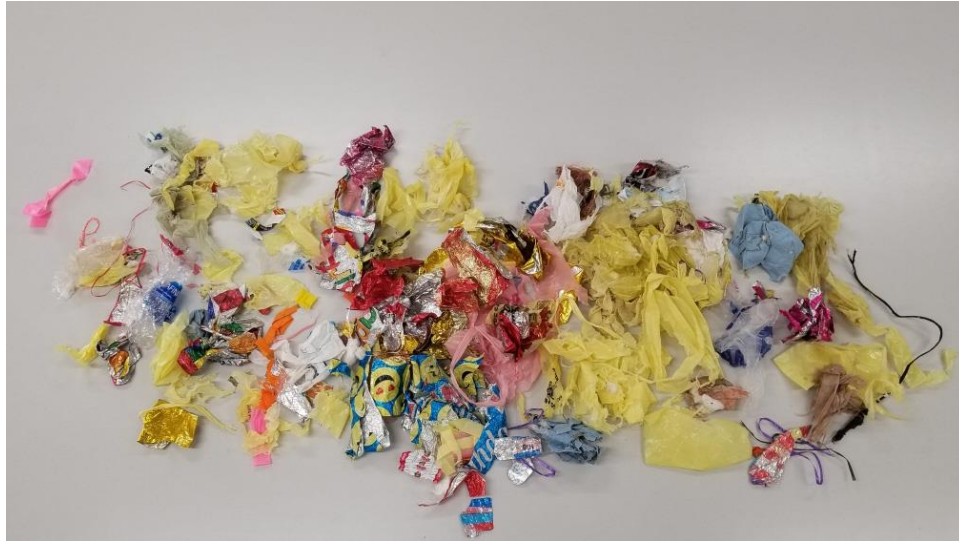
Figure 8. Contamination detected/ejected in 35,000 bales at Southeastern Gin during 2020/21 gin season.

Southeastern Gin operated their VIPR™ systems throughout the entire 2020/21 ginning season. Figure 8 shows the various types of contamination that were detected and ejected by the VIPR™ during the processing of 35,000 bales of cotton. While a major rationale for the development of the VIPR™ was to address round module plastic wrap contamination, Figure 8 clearly demonstrates that while module wrap does contribute to some of the contamination, all types and kinds of contamination make their way into the ginning system.
